MISCELLANEOUS PAPER SL-80-4

# CONCRETE AND ROCK TESTS, MAJOR REHABILITATION AND COMPLIANCE LOCKPORT LOCK, ILLINOIS WATERWAY CHICAGO DISTRICT

U. S. Army Engineer Waterways Experiment Station  
P. O. Box 631, Vicksburg, Miss. 39180

April 1980

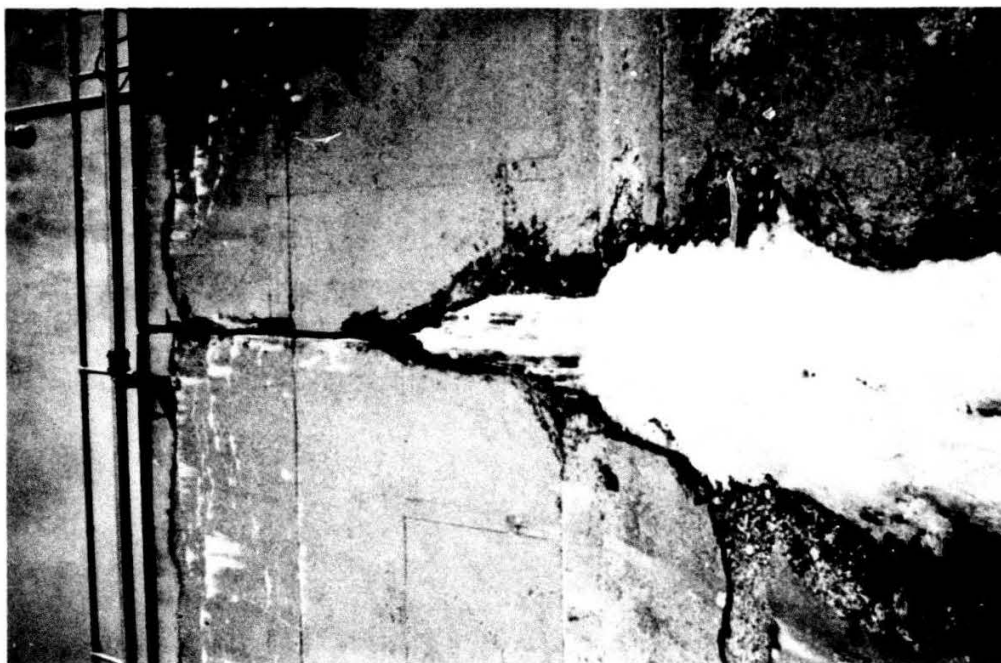
Figure A8. River face, river wall mono-  
lith joint 23-25

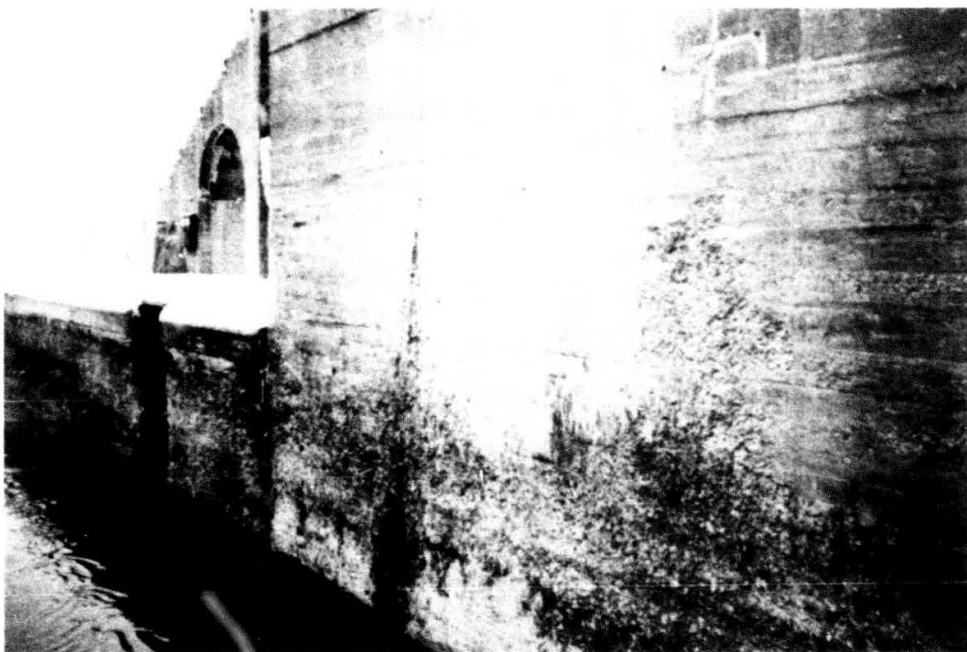
Figure A19. Lock face, river wall monolith 57
